HOUSE DAMAGE ASSESSMENT

URS Research Company

Defense Nuclear Agency

June 1972

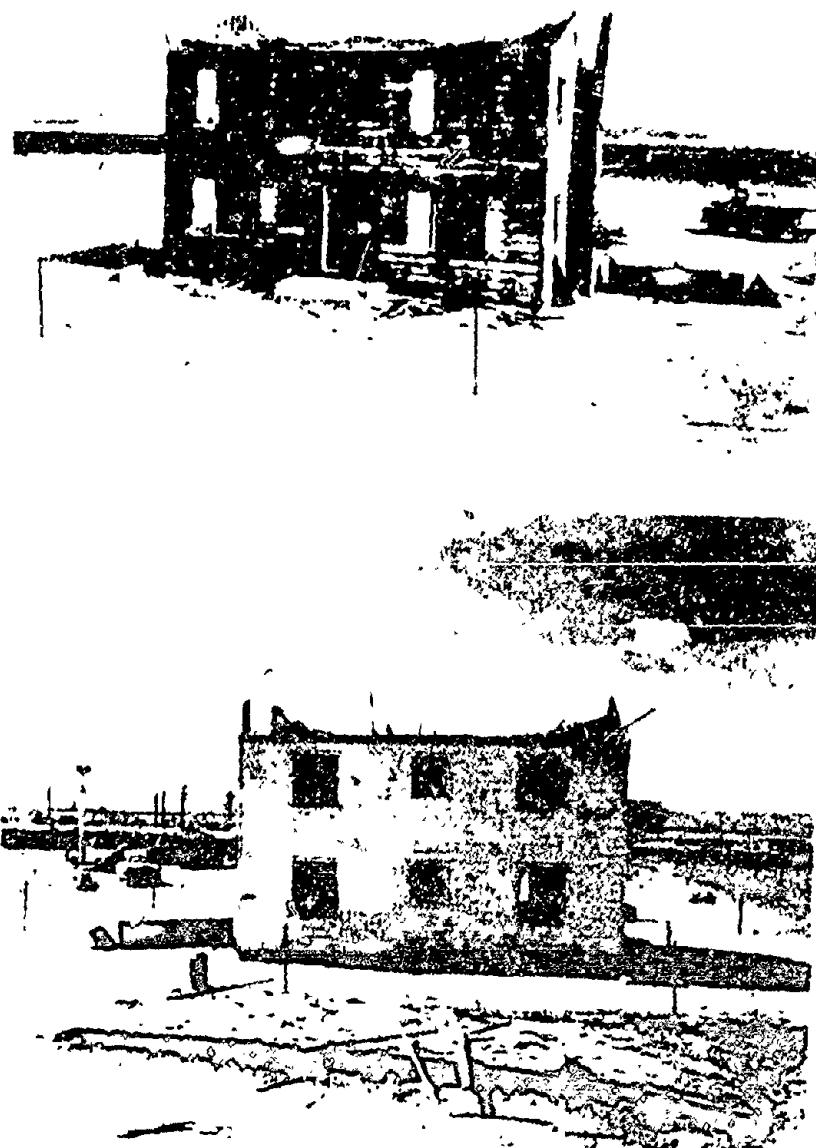
Fig. 2-22. Post-Shot Photos of House 1-3

This house was located 5500 ft from ground zero where the incident peak overpressure was approximately 4 psi. The superstructure of the house suffered severe damage, as can be seen in Fig. 2-22. The blast broke the rafters of the roof at midspan, and flattened the entire front section, with the sheathing and roofing attached, down against the ceiling joists. Most of the 2- by 10-in. rafters were split lengthwise. The rear half of the roof was lifted from the house and was dropped to the ground 25 ft to the rear of the house with the sheathing and most of the shingles attached.

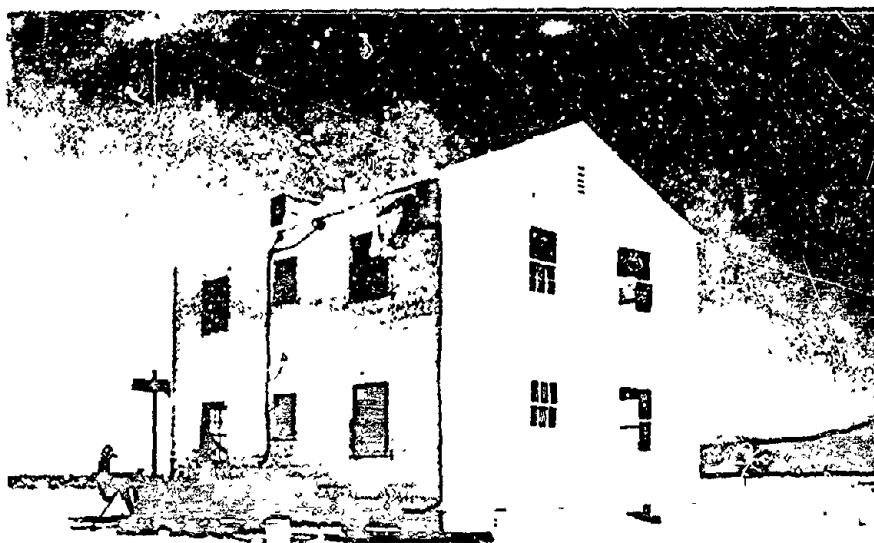
Fig. 2-33. Back and Left Side of House I-6

Although somewhat more severe, damage to the house followed a pattern similar to that seen after the first test. Damage to the windows was slightly more extensive, and a shutter at the upper-left window was torn loose, whereas no shutters were torn loose by the first test. Figure 2-33, a photograph

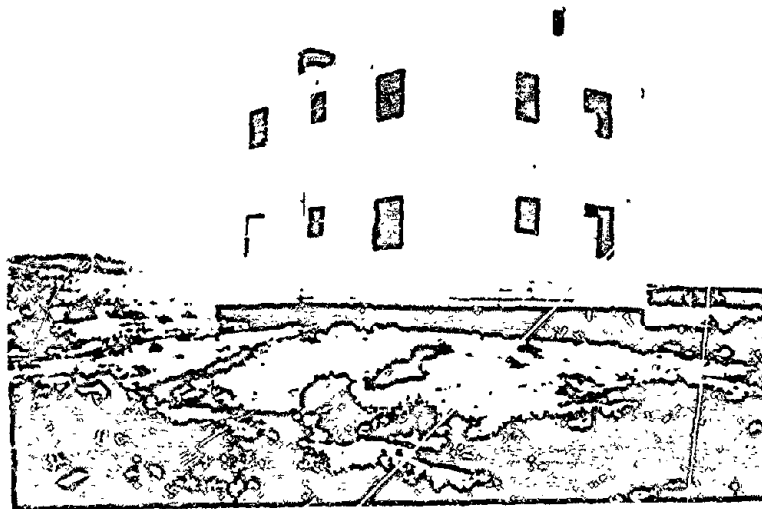
Fig. 2-40. Rear and Left Side of House I-7

Post-test photos of the outside of this house are shown in Figs. 2-39 and 2-40. Other than extensive window damage in the front and sides of the house and removal of the front door, very little exterior damage was noted. There were only minor plaster cracks noted throughout the house, except for significant shear cracks on the sides near the windows. There was extensive

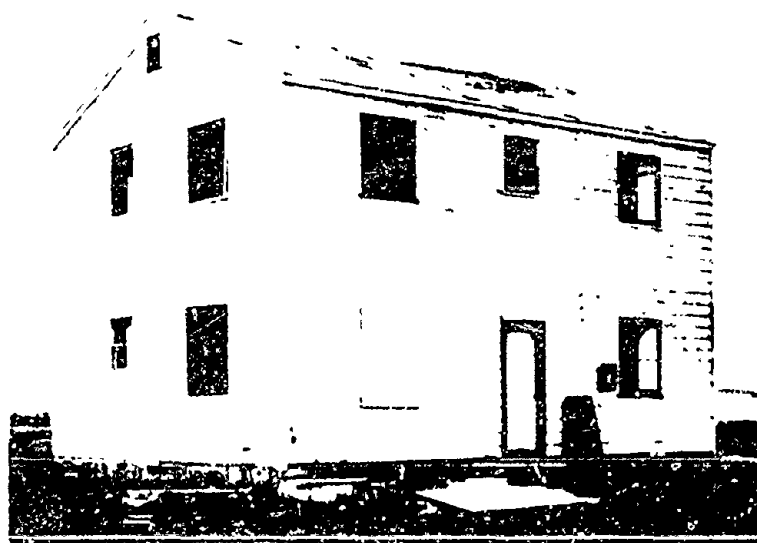
Fig. 2-59. House Exterior, East and South Side of House I-9

East Wall Some siding damage was noted at the corner of each window (see Fig. 2-59).
